PHASE I INSPECTION REPORT
NATIONAL DAM SAFETY PROGRAM

**DELMOE LAKE DAM
BUTTE, MONTANA
JEFFERSON COUNTY
MT-117**

PREPARED BY:
CH2M HILL
BELLEVUE, WASHINGTON

APRIL 1980

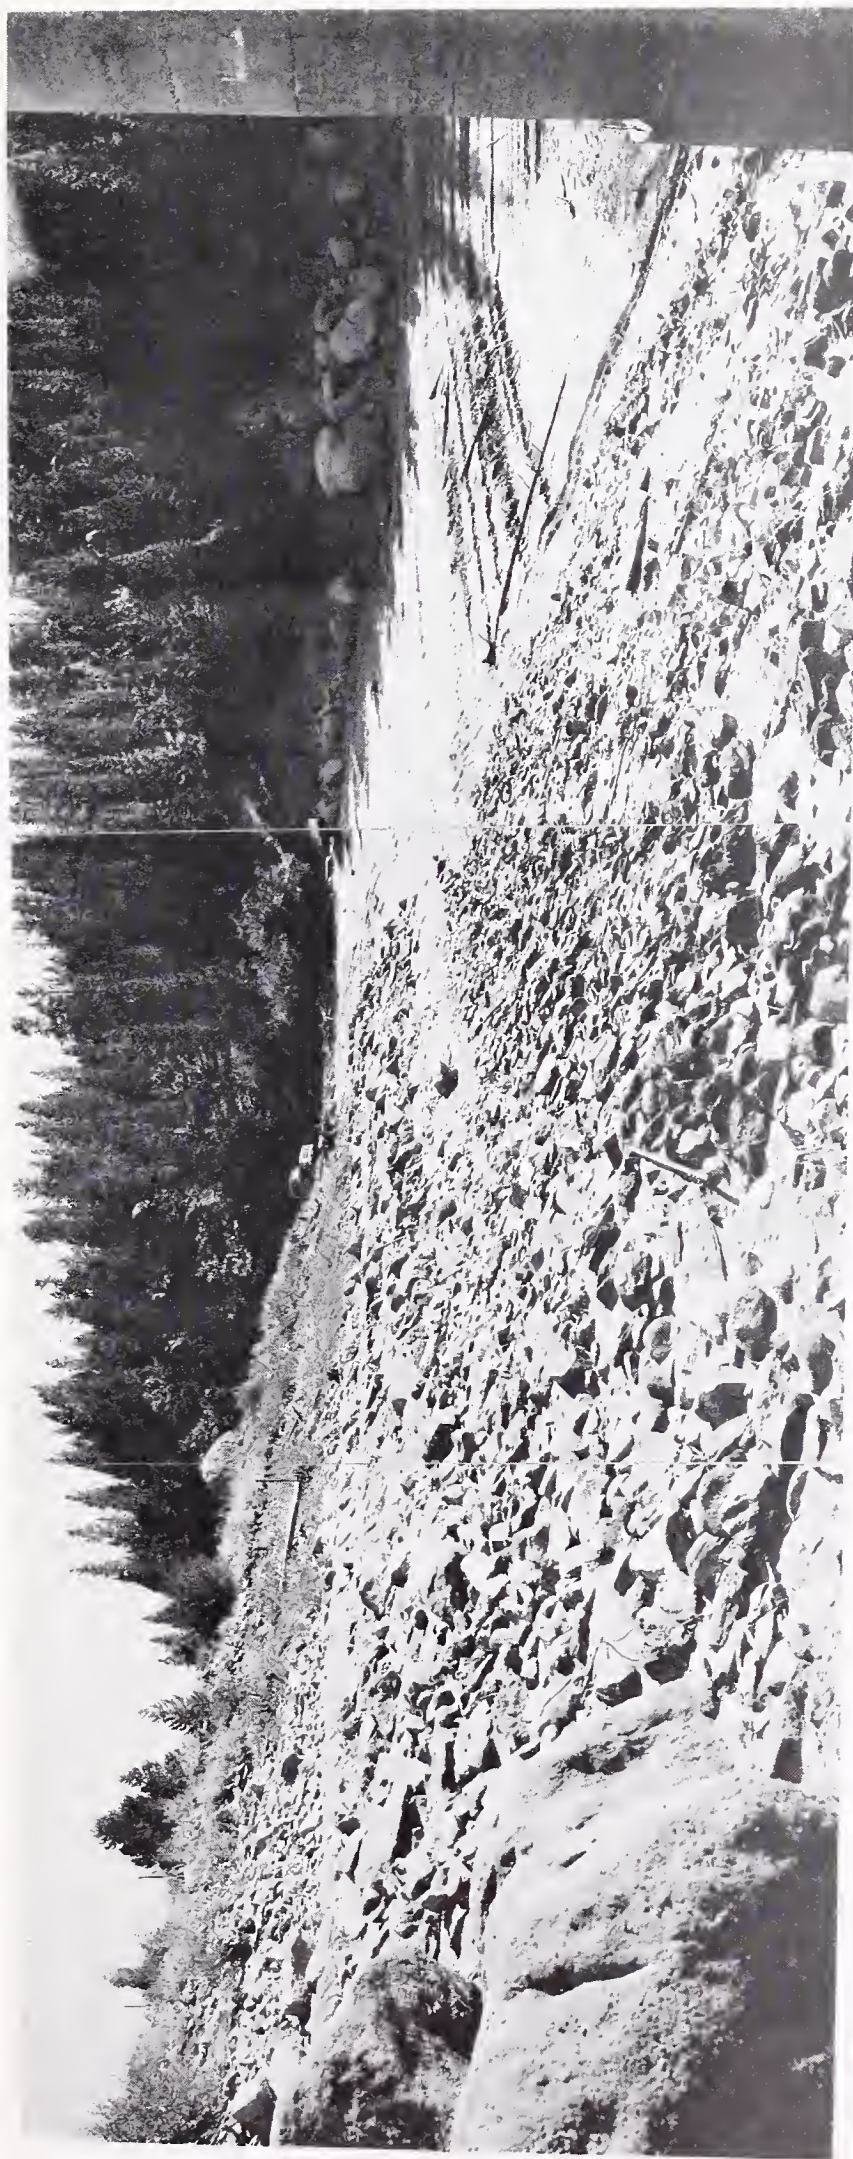
PHOTO 1

Upstream slope in upper
center near pickup, late summer, 1971

6. Repair riprap on upstream face of dam and provide adequate bedding.
7. Remove all brush and trees from dam and toe areas and properly backfill disturbed areas.
8. Regrade the downstream toe area and provide a toe berm with filter protection. This work must be directed by a qualified geotechnical engineer experienced in dam design.

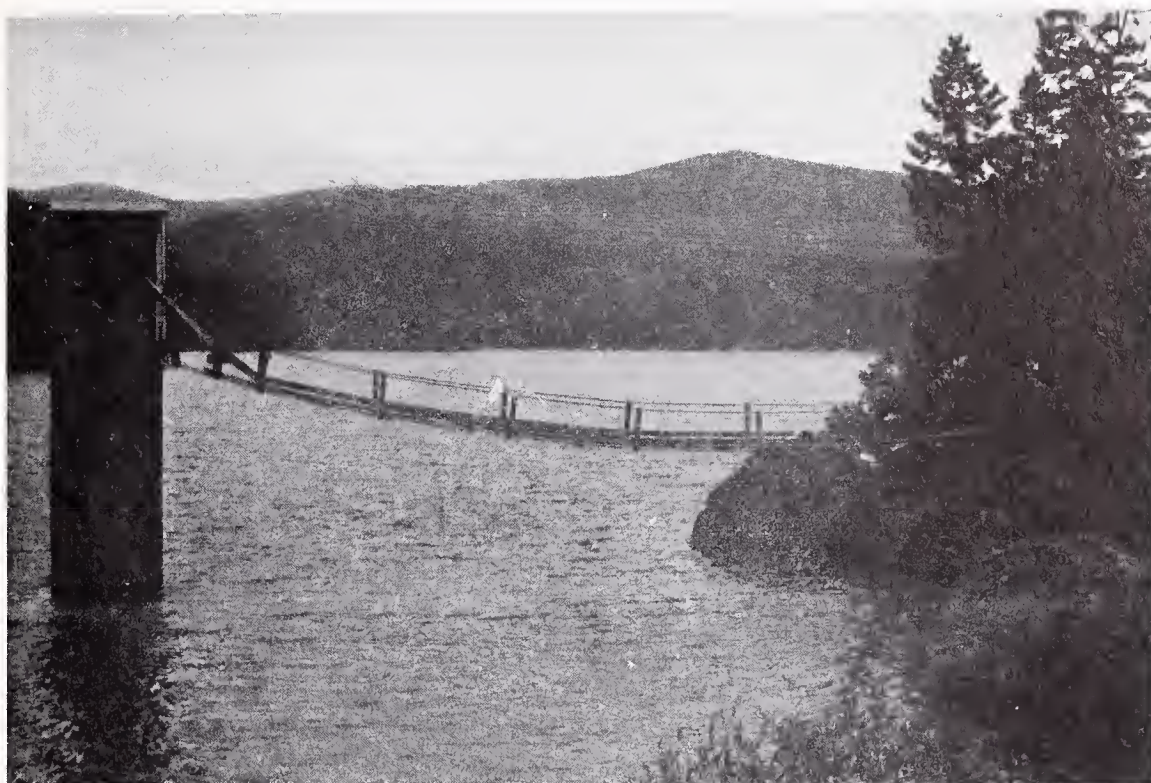
PHOTO 2 Gate tower, 7 June 1979

Detailed inspection of the conduits and the outlet structure could not be made because of discharge through the outlet works. The concrete of the outlet structure contained cracking and heavy spalling but does not currently endanger the safety of the dam. Rock has been stacked along the outlet channel downstream of the dam as erosion protection.

Inspection of the outlet conduits and intake the structure could not be made because of reservoir level. The portion of the outlet structure that could be seen contained cracking and heavy spalling. It does not currently endanger the safety of the dam. Rock has been placed along the outlet channel for erosion protection.

1. Immediately develop, implement, and periodically test an emergency warning plan for use in the event of impending dam overtopping or structural failure.
2. Construct a log boom to protect the spillway from floating debris.
3. Reinforce and raise, as required, the left bank spillway dike to minimize potential for overtopping and/or failure during spillway operation to prevent discharge flows on the dam embankment.
4. Inspect the entire length of both outlet conduits and repair as necessary.
5. Repair or replace outlet valves and appurtenant metal as required.

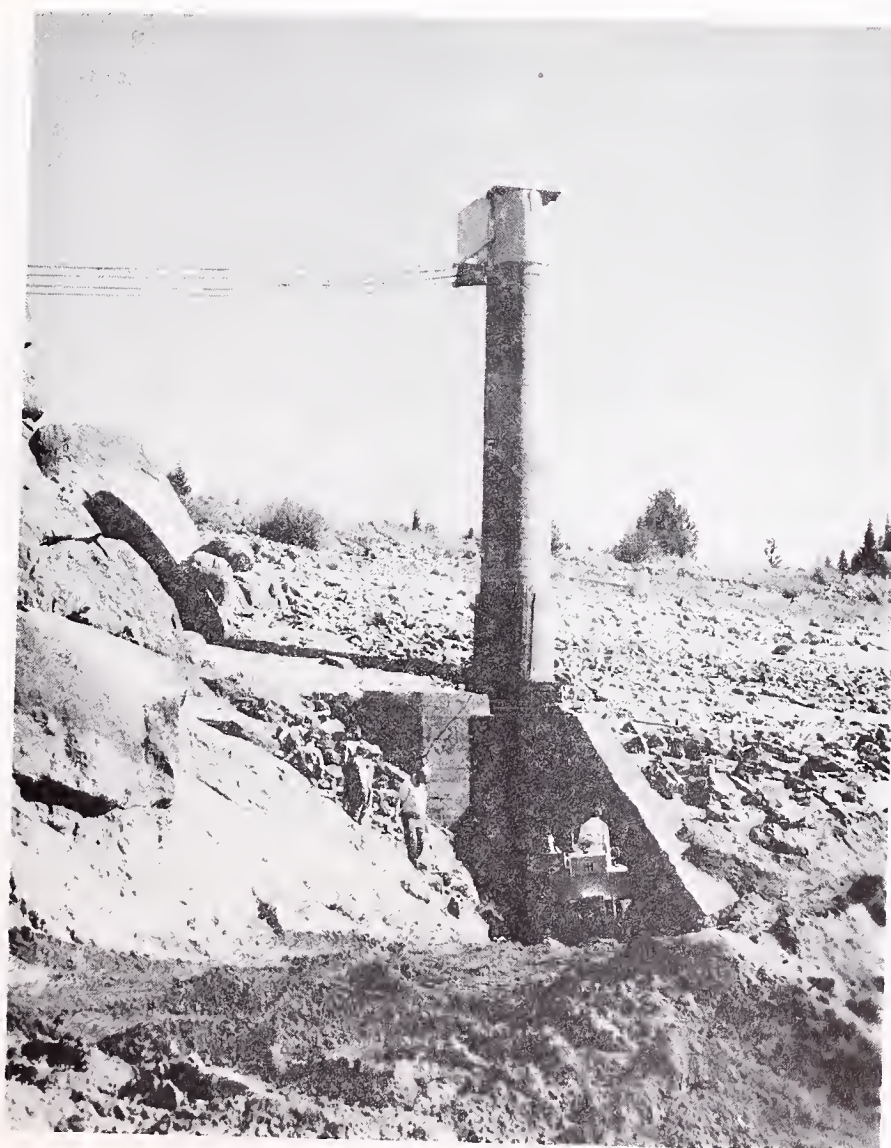
PHOTO 3 Gate tower, late summer, 1971

Maintenance of the dam is performed as required. Maintenance of the intake structure, including cleaning rock and mud from the approach channel, was performed in 1971 when the reservoir was drawn down. According to Forest Service records, additional repairs were made to the gate valves and valve stems. The riprap on the upstream face of the dam requires maintenance. The intake tower was not inspected to determine whether corrosion of the valves and appurtenant metal (including steel conduits), mentioned in previous inspection reports, has been remedied.

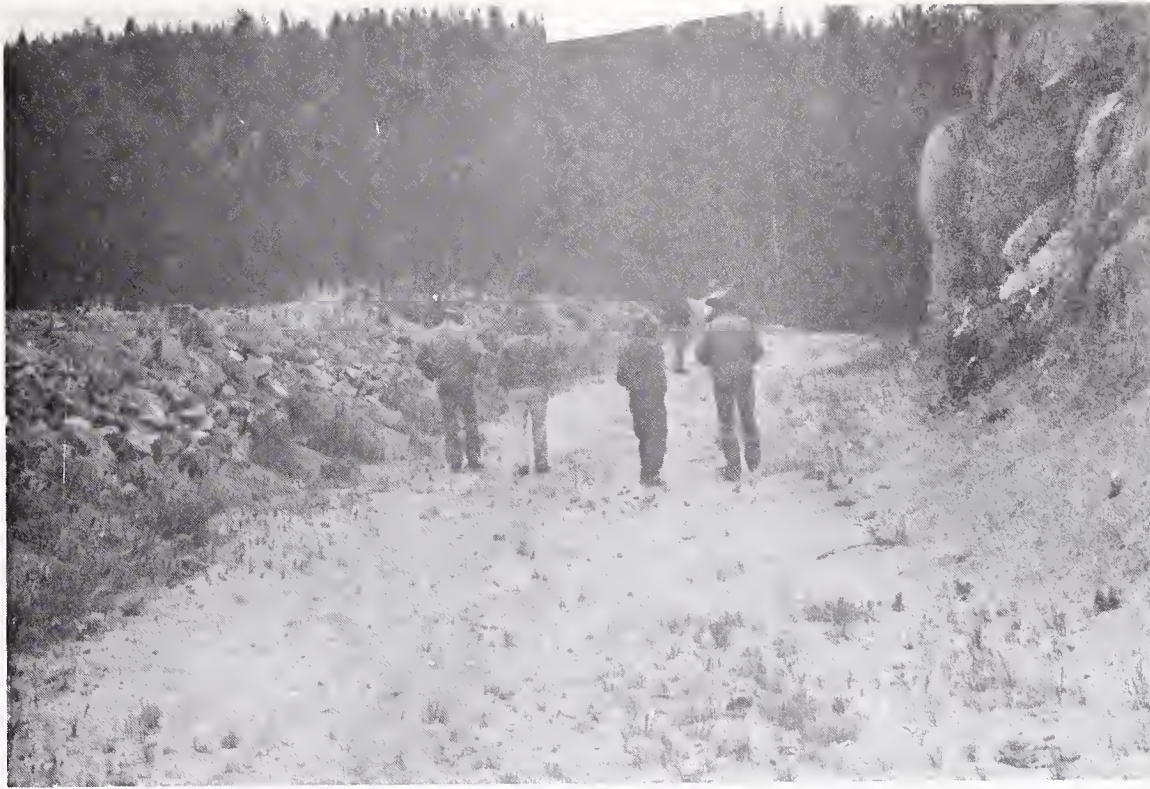
PHOTO 4 Spillway chute, looking downstream,
 (note dike on left) 7 June 1979

Sustained spillway discharges will cause erosion of the chute floor and the retaining dike. Failure of the dike 80 to 100 feet downstream of the chute entrance could cause flows to reach the dam embankment. Erosion of the dam embankment could result in failure. Also, a low point on the dike at this location may be overtopped by discharges less than the maximum computed discharge. The erosion at the downstream end of the chute does not affect dam safety.

(a) the spillway has no log boom; (b) the unlined spillway channel may be heavily eroded by sustained discharges; and (c) the dike along the left (looking downstream) side of the channel may erode and cause spillway flows to infringe upon the dam embankment.
